Arsenic Policy Support Unit

# **Water Safety Plans in Bangladesh: Experiences from Pilot Projects**

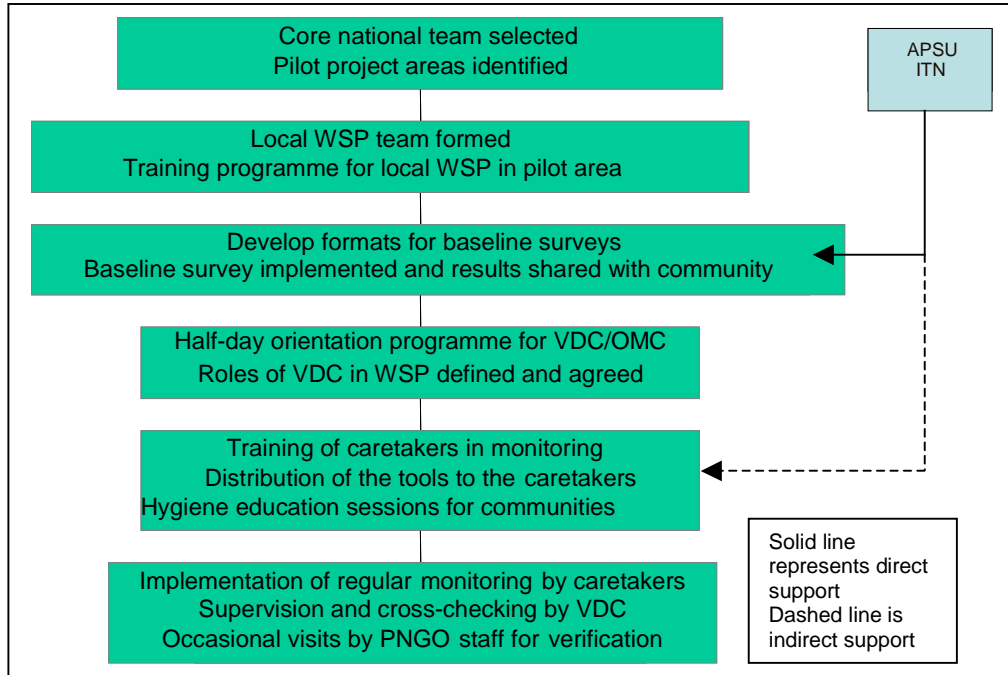
After the training, the implementation of the WSP was initiated by the caretaker and was cross checked and supervised by the VDC/OMC members. VDC's supervision was also supported by visits made by the local WSP team members. The generic process steps for the implementation of WSP pilots are illustrated in Figure 3.2.

**Figure 3.2: Stages of implementation of the pilot projects**

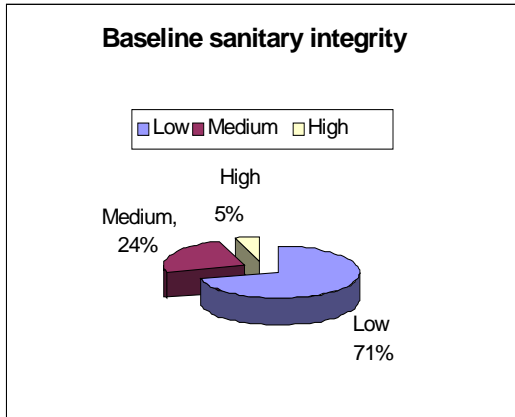
Sanitary inspection survey results revealed that during the first phase of the pilot project about 30% water options were in either the medium or high risk categories (Figure 4.1). This was reduced to 14% at the end of the project (Figure 4.2).

**Figure 4.1: Sanitary risks at baseline**

<b>Risk category</b>	<b>Risk score</b>
Low risk	0-3
Medium risk	4-6
High risk	7 and above

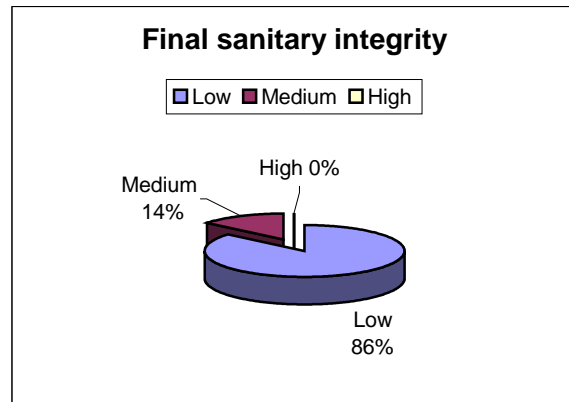
**Figure 4.2: Sanitary risks in final survey**

During the baseline survey rainwater harvesters had the highest numbers of sources in medium to high risk, followed by arsenic-iron removal plants (AIRPs) and dug wells (Table 4.3). It was unexpected for the rainwater harvesters to be the source with the highest numbers at medium to high risk. The underlying reasons for this are not clear. One possible reason, however, is that the rainwater harvesters were not in use during the baseline survey as this was done in the dry season. Equally, it may also reflect that rainwater harvesters are not a popular option. Piped water supply system always demonstrates good sanitary integrity, with all supplies in the 'low risk' category.

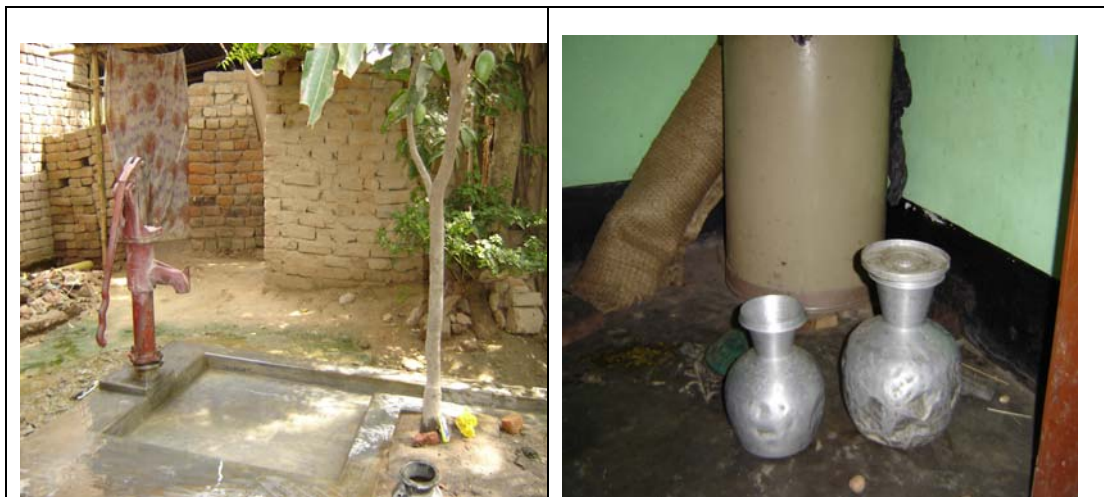
Apart from water quality and sanitary risk it was observed during visits to the communities that general cleanliness of the surrounding of the water points was improved to a considerable extent. Figure 4.3 demonstrates such improvements.

**Figure 4.3: Improvements in water source maintenance and water storage**

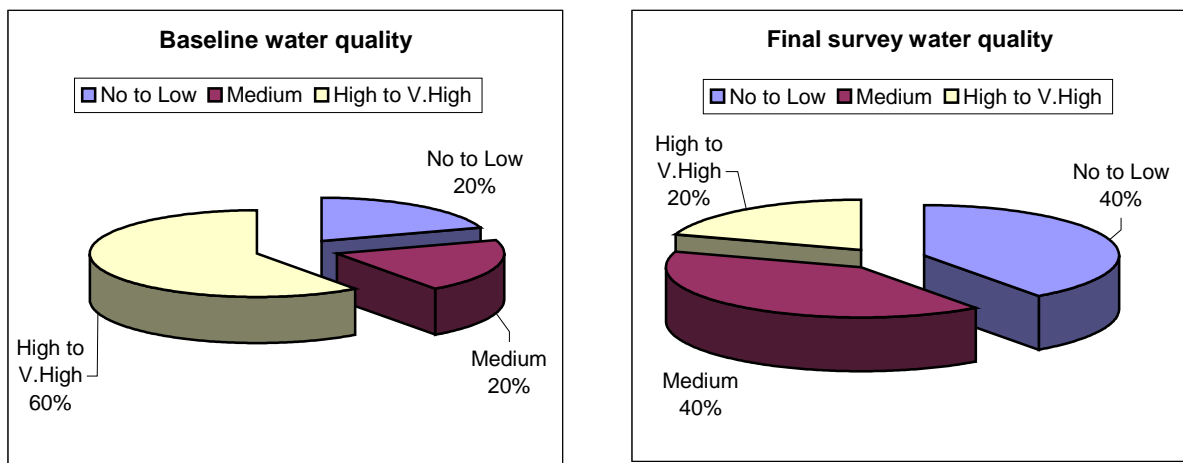
For pond sand filters, a reduction in the number of samples in the high and very high risks categories decreased by 40% and the proportion of samples in the no to low risk category increased by 20% (Figure 4.8). Overall the median concentration of thermotolerant coliforms also decreased significantly between the baseline and intermediate surveys (185cfu/100ml and 60 cfu/100ml) and the final survey (36 cfu/100ml).

**Figure 4.8: Microbial quality of pond sand filters at baseline and final survey**

The effect of chlorination at pond sand filters was again seen as important for improvement in water quality. For pond sand filters where both source chlorination and WSP training was provided, the median contamination reduced from 48cfu/100ml at baseline to 17cfu/100ml at the final survey. Again, quality deteriorated between intermediate and final surveys (median at the intermediate survey was <1cfu/100ml), which coincided with transfer of the chlorination technology to the community. For communities receiving WSP training alone showed a progressive improvement in water quality from 280 cfu/100ml at baseline to 37 cfu/100ml at the final survey.

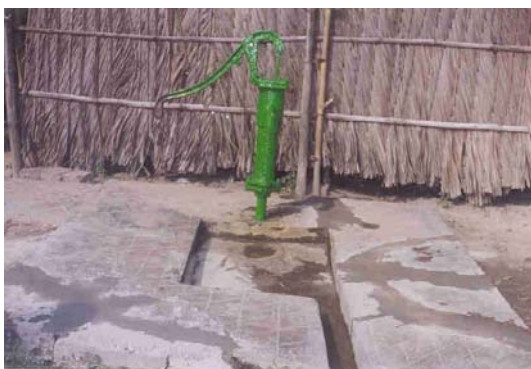
For the users, the WSP concept opened a new window of thinking regarding safety of water in an integrated way. The WSP team was able to make the community understand about the possible causes of water contamination in the water source and within their domain (i.e. during water handling from collection to consumption point). The reorientation of knowledge on water safety provided an impetus to communities in keeping their water points clean and in practicing improved hygiene during water handling, Figure 4.13.

**Figure 4.13: Caretakers are maintaining clean environment around the tubewell**

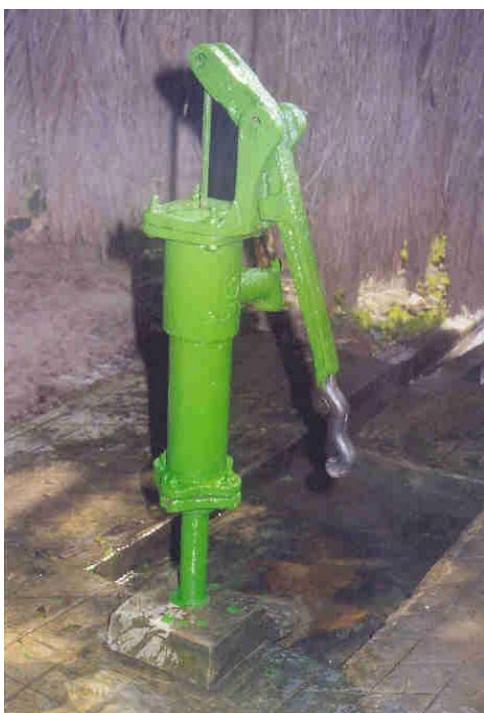
**Figure 4.14: Caretakers painted their tubewell as a symbol of a safe water point**

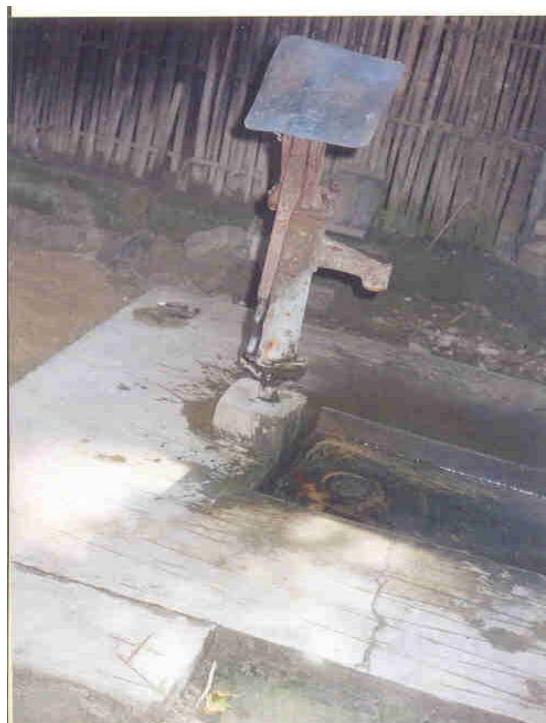
The caretakers had received training on the repair of water points at different times under different programmes. The approach of training had been to make them able to restore the supply of water through repairing. However, the WSP concept clarified the possible pathways of contamination at source as well as during handling. This knowledge shifted the focus to preventive maintenance from repairs to damage. Caretakers were seen to undertake repairs of cracks and damaged areas of tubewell platforms and painting of the handpump (Figure 4.13). Painting was done to give a better aesthetic value to the water point and to emphasise its safety, as shown in Figure 4.14. In addition improvements in the cleanliness of tubewell platforms and other water supplies were noted, as shown in Figure 4.15.

**Figure 4.15: Cleanliness of tubewell surroundings improved**
